## Stormwater Facility Inspection Photo Log

Facility: Lake 1

Facility Owner: Tabb Lakes Homes Association Inc.

Date: 5/16/24

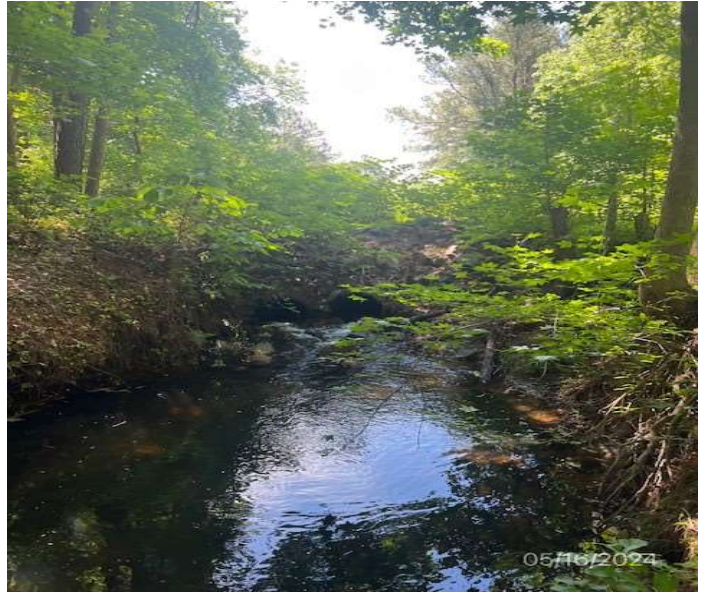
Location: N

Walked Lake 1 with Mr. Lafrenaye on 5/16/24. Lake aesthetic quality is well maintained by the Tabb Lakes HOA. All inlets associated with the lake were not able to be properly inspected due to them being on private property and had to be viewed from the opposite side of the lake. No signs of major erosion or loss of inlet protection were visible from my viewpoint but the next inspection will have to be done from a boat in order to certify structural integrity of inlet structures and inlet protection. Vegetative overgrowth was noted on banks opposite of homes and in locations K and L in the above photo log. Mr. Lafrenaye assured me that these issues have already been recognized and are being addressed within the confines of the HOA stormwater budget. The emergency spillway (location N) is partially clogged with sediment and vegetative debris and will need to be cleaned out.
