December 11, 2000

**RE: Sediment Load Analysis
Tabb Lakes Homes Association**

Sediment Load Analysis

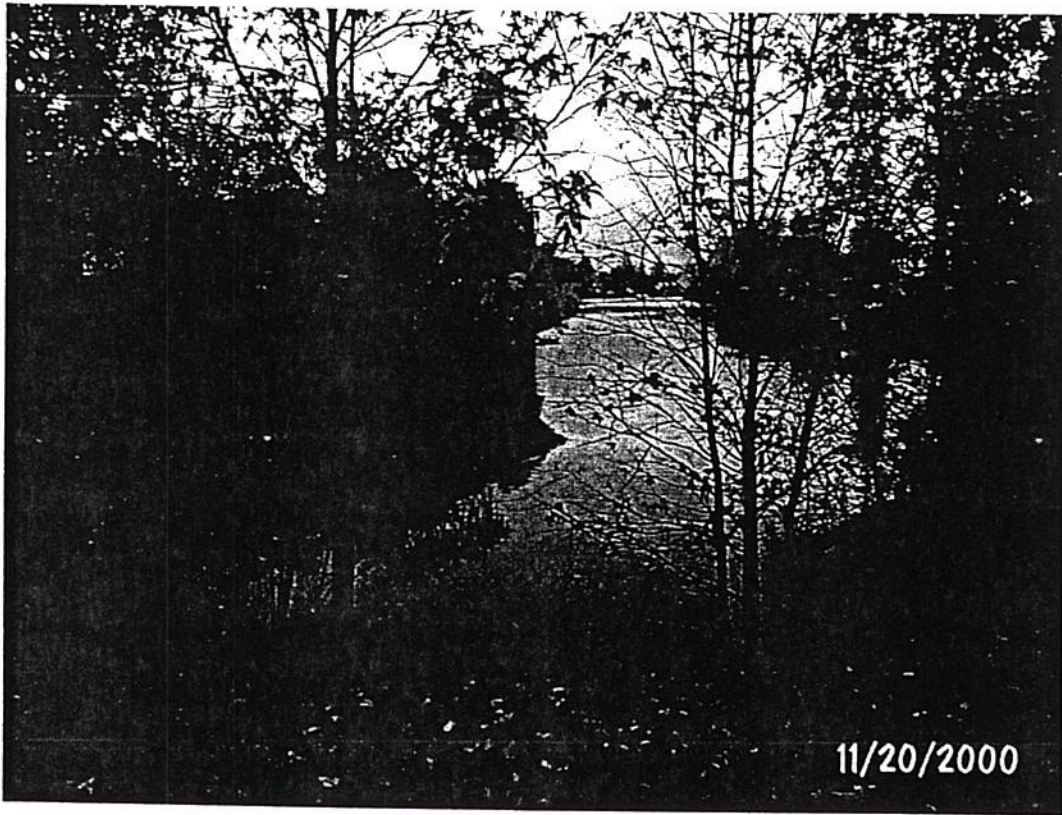
Photo #1 – View of Lake 2 from Bridge Wood Drive looking south

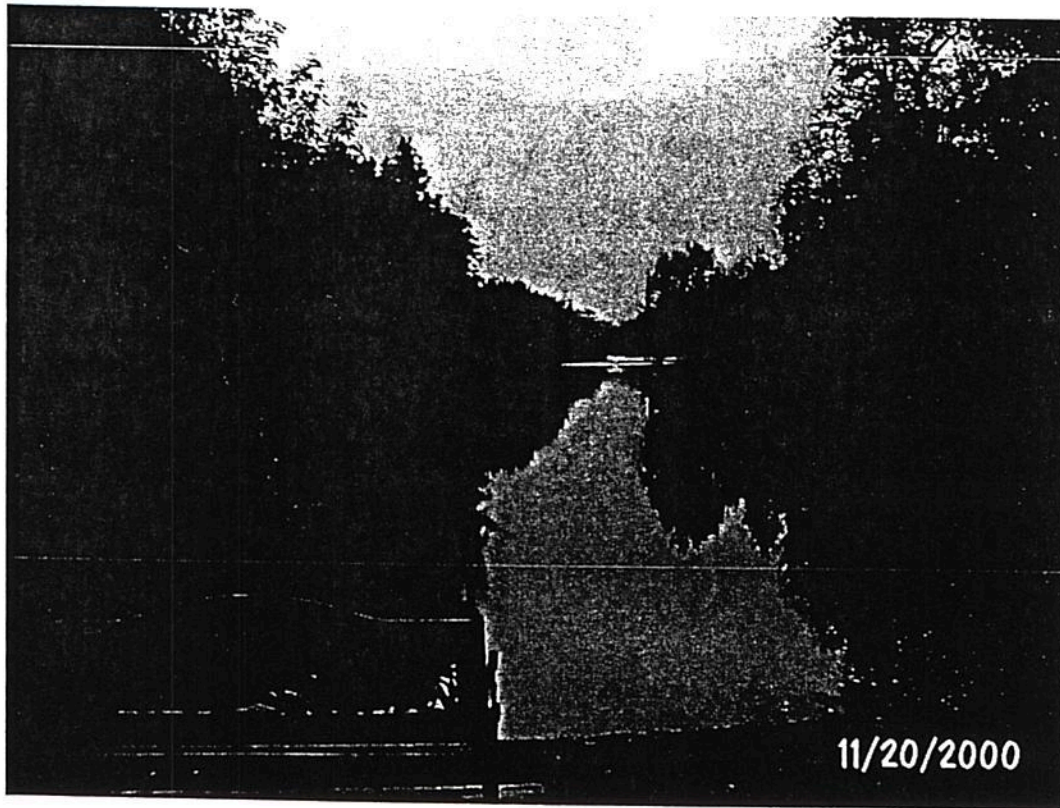
Photo #2 – View of Lake 1 from Bridge Wood Drive looking north

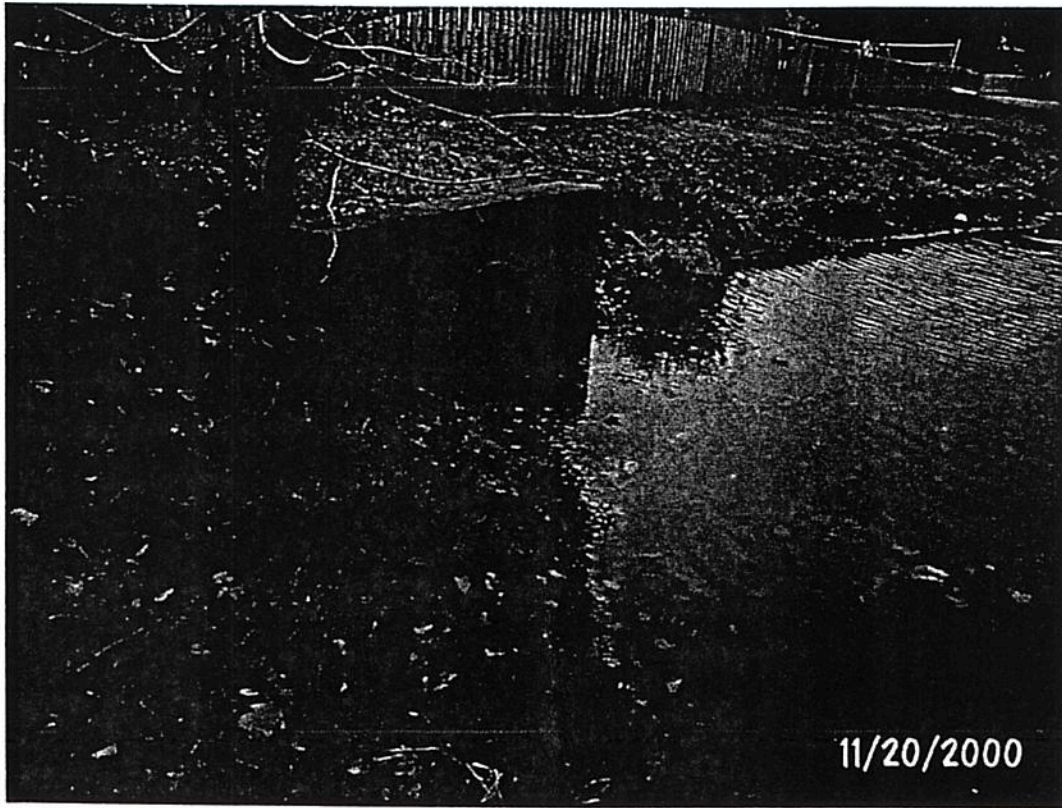
Photo #3 - View of an inlet pipe to Lake 2

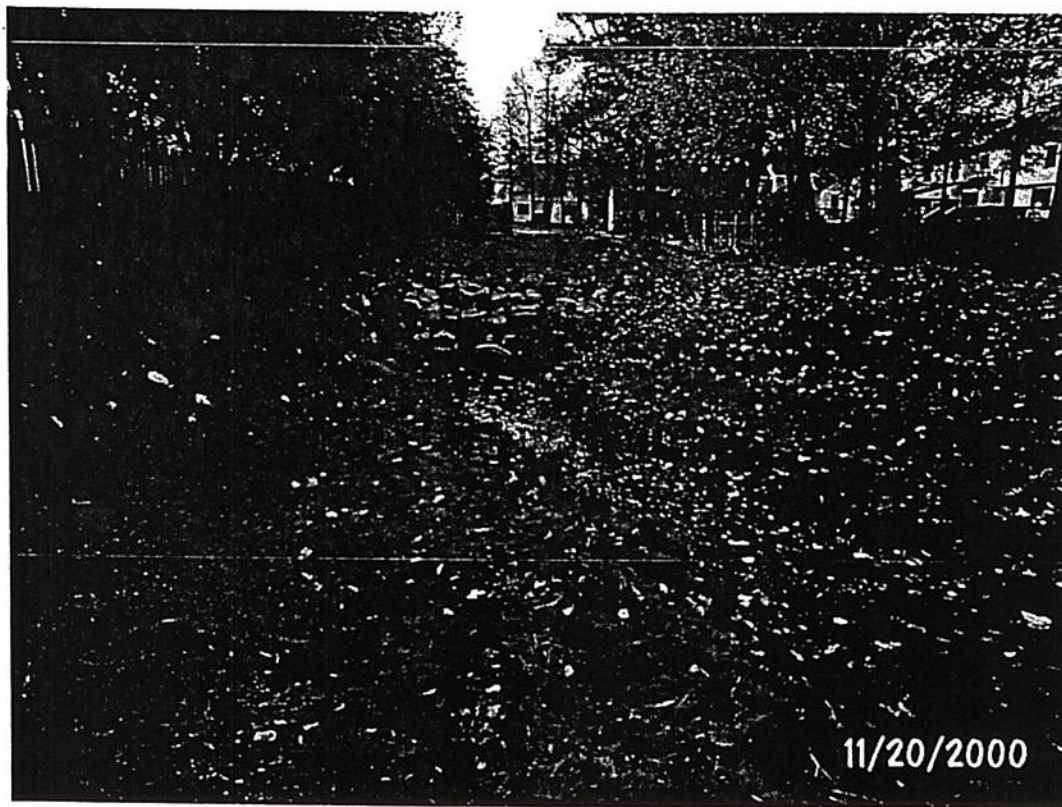
Photo #4 - View of twin pipes leading to the south end of Lake 2 from Richard Run

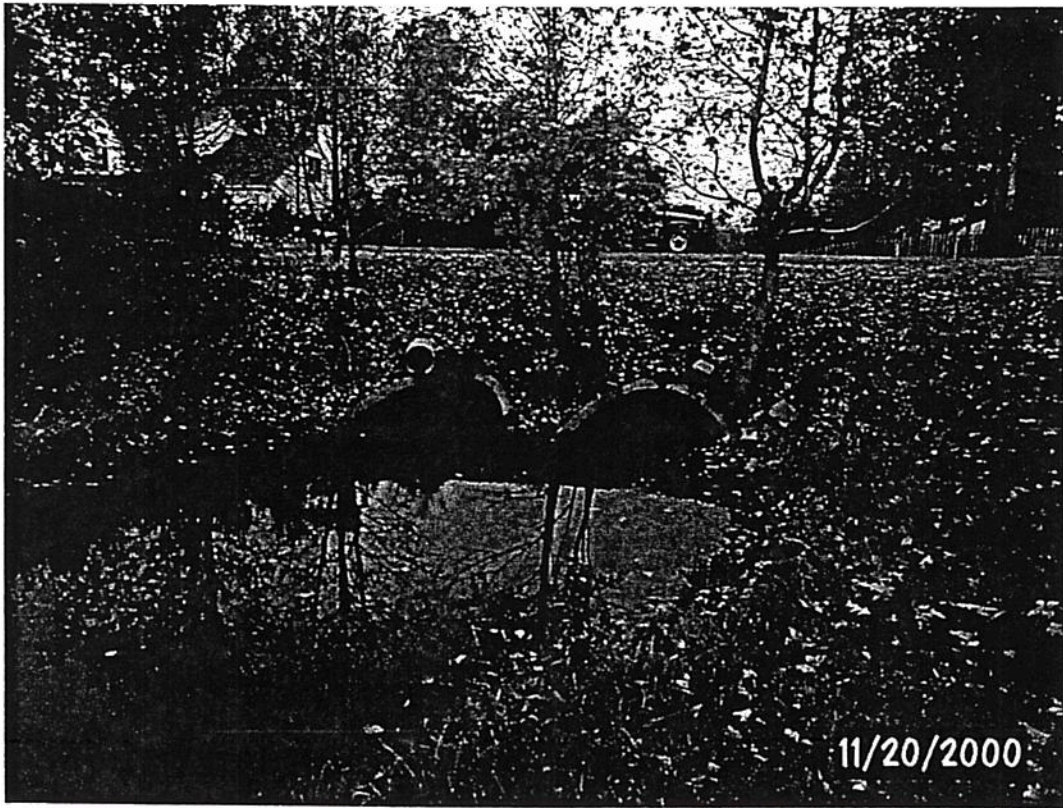
The field assessment portion of this task also included an assessment to evaluate the watershed for the two lakes. The Tabb Lakes subdivision consists of 446 homes located within the area bounded by Rt. 17, Rt. 134, and Rt. 171 (Victory Boulevard). Stormwater runoff from the subdivision drains north through two interconnected lakes, flows under Rt. 171, and ultimately drains into the Poquoson River. The Sediment Load Analysis plans show 17 inlet points, either pipes or swales, where stormwater enters the two lakes. Several inlet locations showed evidence of older sediment deposits in the lake, but the majority of the inlets showed no significant sediment deposition. The lakes within the Tabb Lakes subdivision were designed as a stormwater system connected by twin elliptical pipes under Bridge Wood Drive. Approximately 9 to 10 inches of sediment and rock was noted in those twin pipes connecting the two lakes.

Photo #5 – View of twin elliptical pipes under Bridge Wood Drive looking north

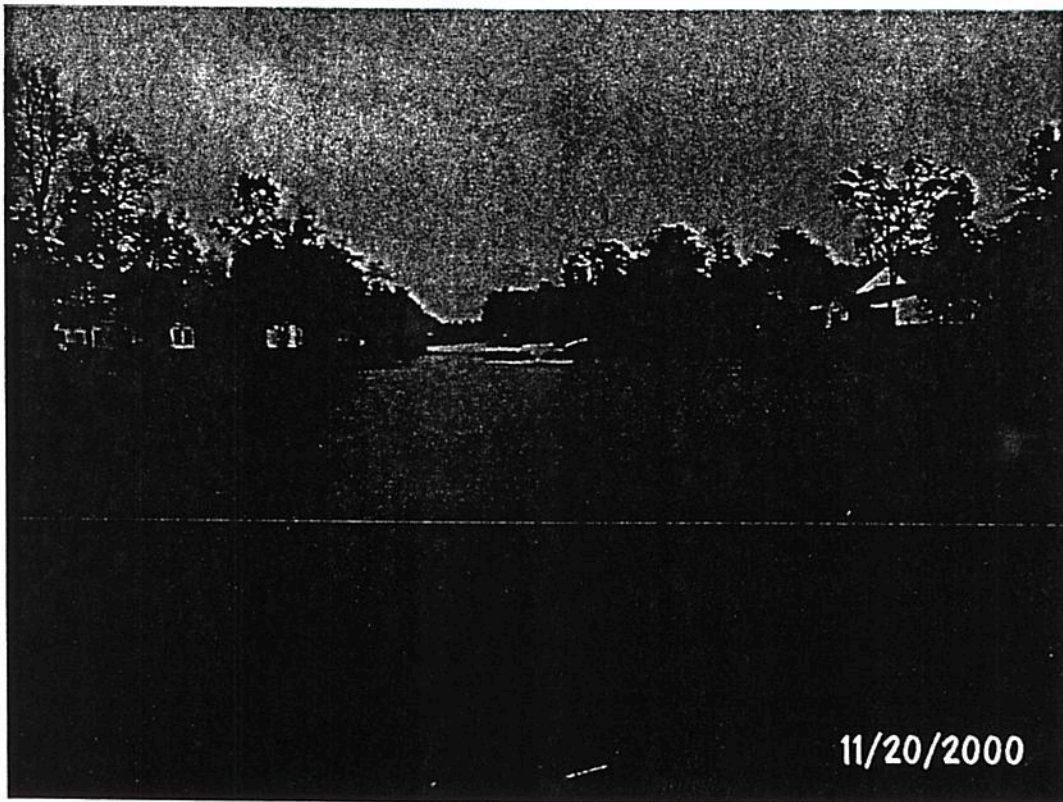
The lakes in the Tabb Lakes subdivision are approximately 15 years old but they appear in good condition. The south end of Lake 2 is fairly shallow which has caused problems with algal growth and the operation of a fountain. Based on the results of the sediment load analysis, however, it appears that this section of Lake 2 was not constructed to its design depth of 6 feet. On the average, only a foot of sediment was measured in this section of the lake. Lake 1 and the north end of Lake 2 are deeper and appear to have fewer problems with algal growth. Overall, the shallow depth in Lake 2 is not a result of significant sedimentation but the fact that neither the lakes nor the outfall structures were constructed in accordance with the design plans.

Photo #6 - View of Lake 2 from the south end looking north

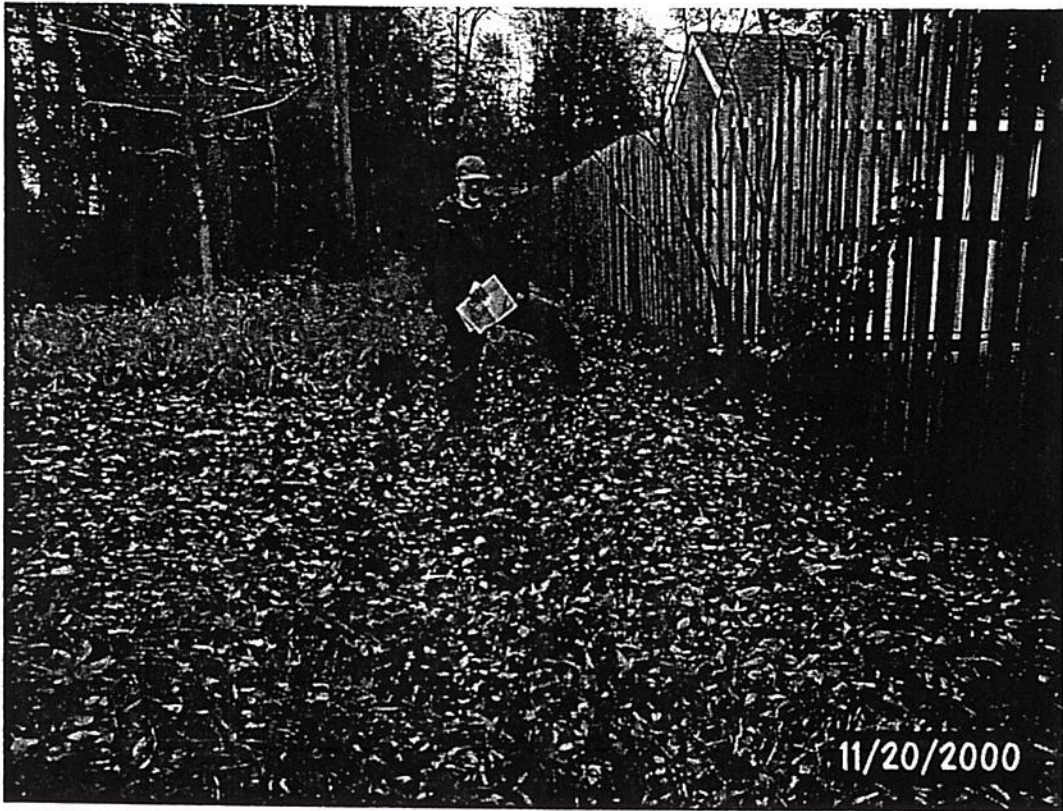
In addition to receiving the additional residential runoff, the lakes also collect runoff from existing commercial properties along Rt. 17. Currently, runoff from the commercial properties along Rt. 17 sheet flows to the back of the properties and then flows along a grassy channel north towards Lake 1. In an attempt to keep large amounts of water from flooding the backyards within Tabb Lakes abutting the commercial properties, York County constructed a small berm to direct the runoff towards an existing channel to the lake. Although the berm appears in good condition, the lack of an adequate channel on the west side of the berm prohibits positive drainage of this runoff to the lakes. WEG recommends the regrading/construction of an adequate channel to handle stormwater from the commercial properties.

Photo #7 – View of berm behind businesses along east side of Rt. 17

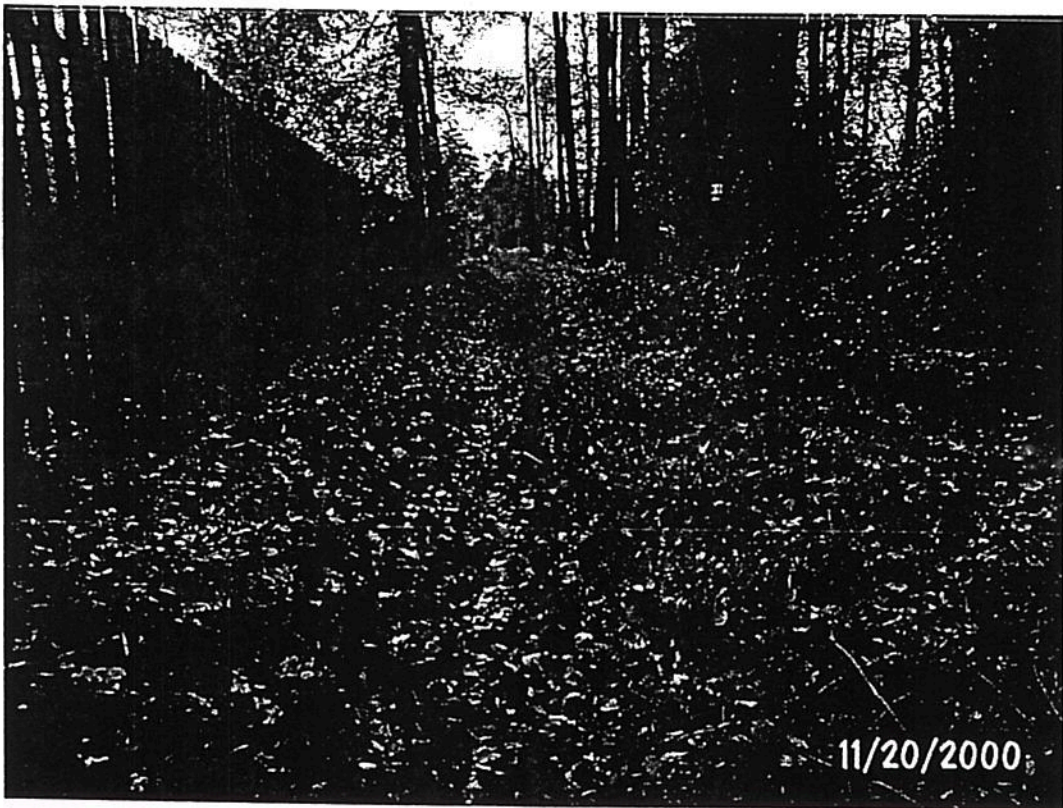
Photo #8 – Ditch draining businesses behind east side of Rt.17
