Reference: Report of Subsurface Exploration
Tabb Lakes Dredging Investigation
York County, Virginia

Earthworks Project No. 1303

ENCLOSURE I
FIELD SAMPLING LOCATION DIAGRAM
TABB LAKES DREDGING INVESTIGATION
Earthworks Project No. 1303

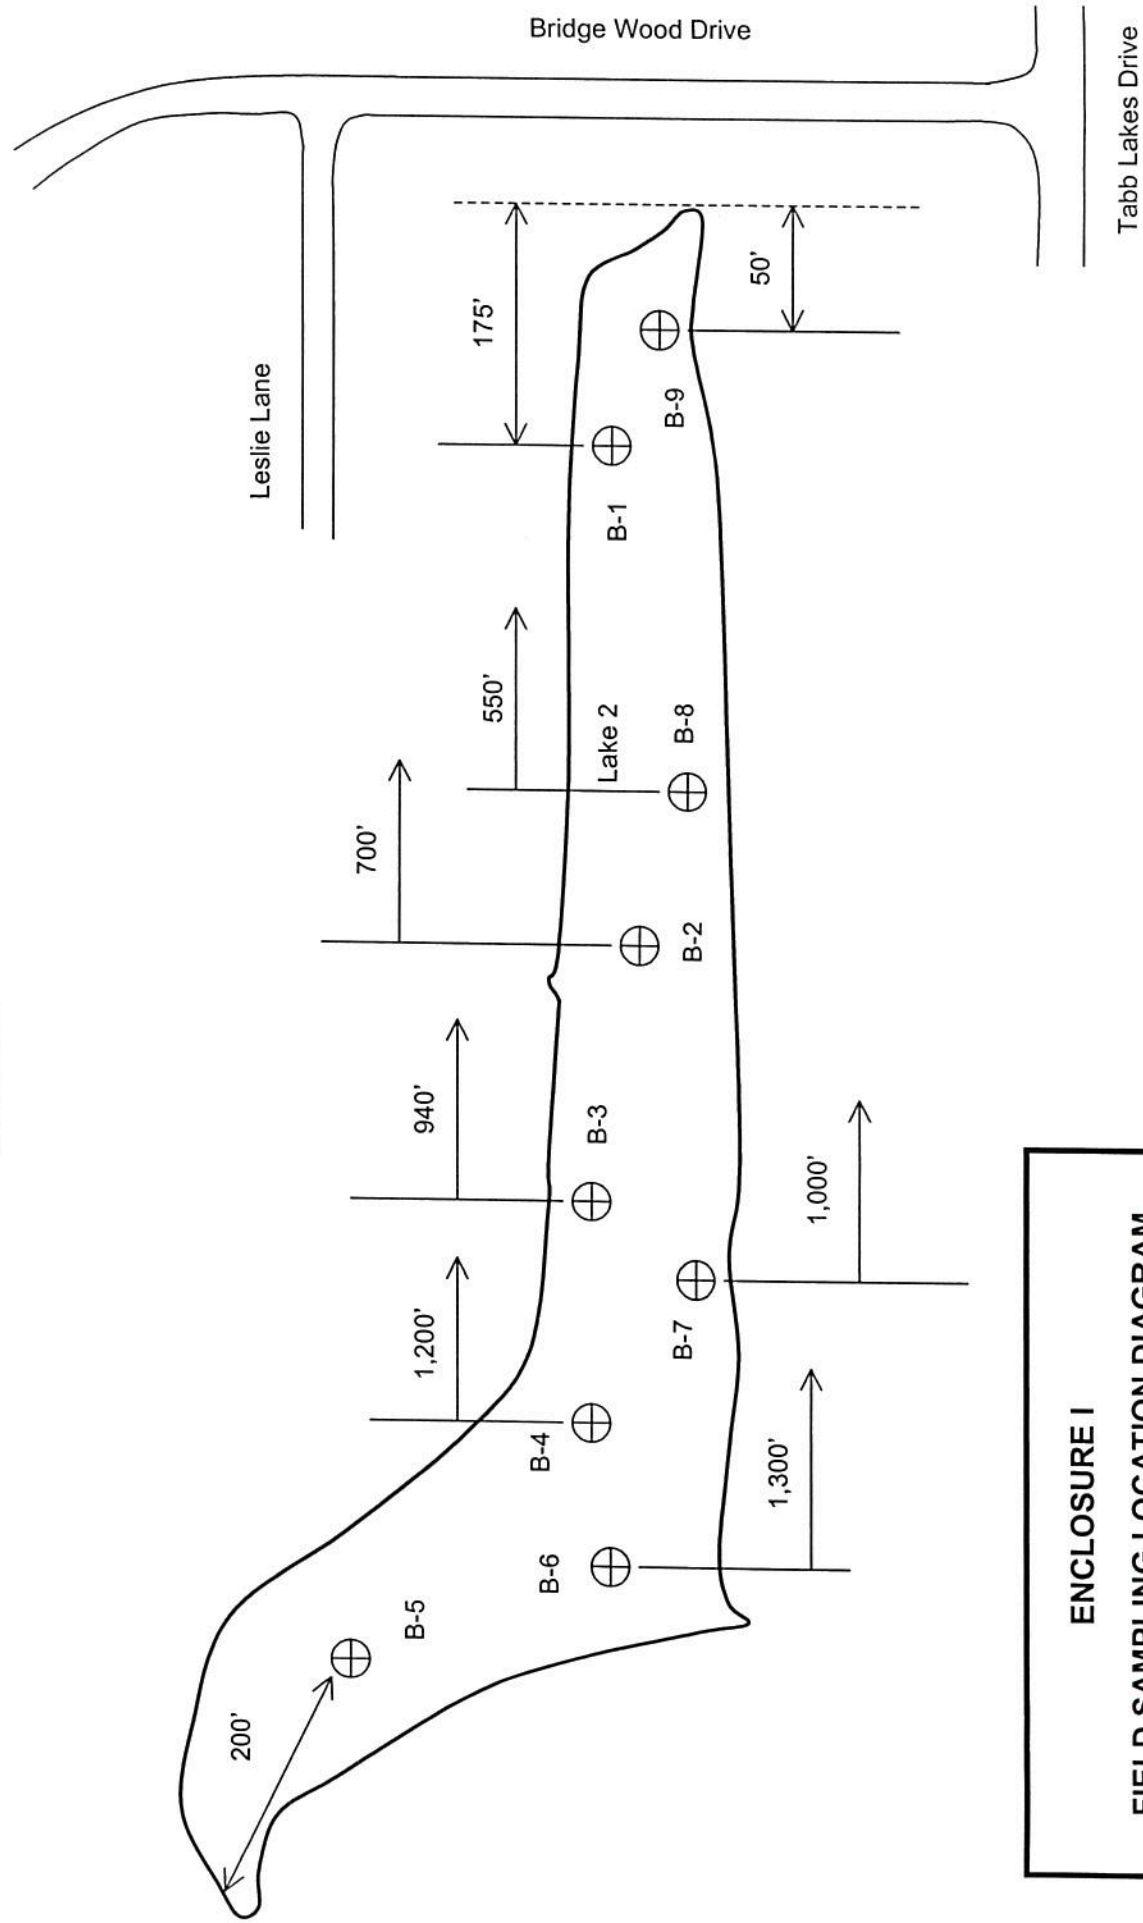
Based on the results of our field sampling, it appears that lake depths observed by Earthworks are generally consistent with those shown on the project drawings, except that we encountered somewhat deeper water at the south end of the lake (see Enclosure II, B-5).

Soils underlying the sediment layer consisted primarily of gray, fine to medium SAND (SP and SM). Some of these Sands contained marine shell fragments, indicating they are probably from the original lake bottom and not accumulated sediment. While most soils encountered below the sediment were Sandy in nature, Clayey soils were encountered below a thin layer of sediment in the vicinity of B-3 and B-7. These were relatively shallow areas in the vicinity of what may have been a road crossing, now submerged, of the original Sand pit from which the lake was created. This area is midway between cross-sections K and J on the project drawings.

Furthermore, it appears that Clay soils which were encountered in the shallower waters in the vicinity of B-3 and B-7 would be resistant to hydraulic dredging, as they appear to consist of relatively stiff Clayey SAND (SC) and Sandy CLAY (CL). A dredging contractor may determine that this area requires mechanical excavation.
