Tabb Lakes Dredging Project  
Lake 1 South End  
Dredged July 2018

Information below is a synopsis of the process undertaken by the Tabb Lakes Board of Directors (BOD) and Committee members to complete the dredging project for the southern portion of Lake 1.

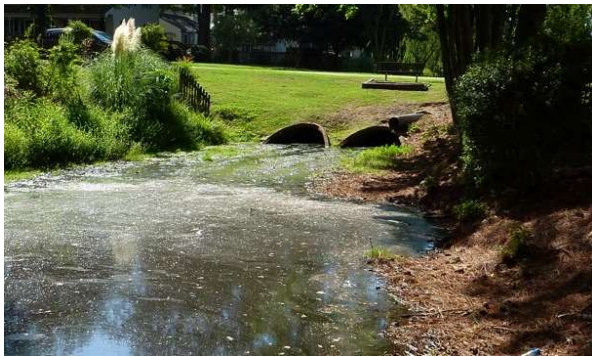
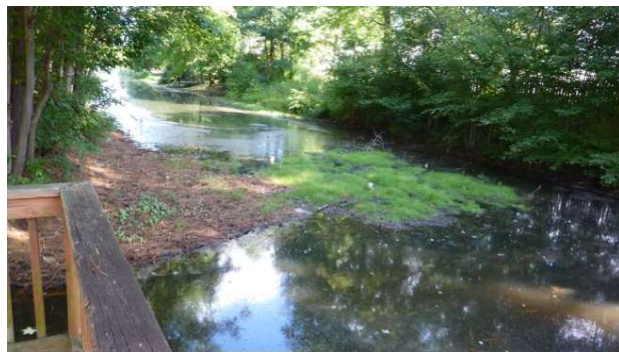
Our analysis showed that approximately 150 ft by 25 ft area at the southern end of Lake 1 needed to be dredged. The buildup of organic matter occurred due to the numerous trees on the west bank of the area dropping leaves, needles, and branches into the lake along with the significant drainage from the open cement swale perpendicular to the lake near the observation pier. Unlike other areas in Tabb Lakes, the open cement swale allowed significant amount of additional leaves, needles and debris to wash into the lake filling in this particular area over the years. Since the outflow point was next to the pier, it unfortunately contributed to trapping some of the debris in the area. It was estimated that sediment buildup was up to 6 feet deep in the deepest area.

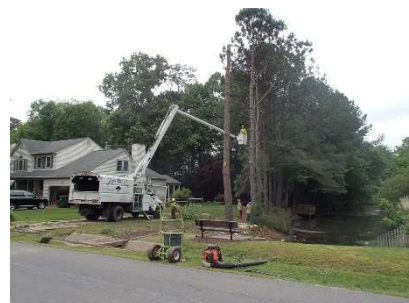
Earlier in 2016, three tree removal companies were contacted and provided bids to remove the tress on the west bank of the area to be dredged. Ash Tree Service was the lowest bidder. Once the dredging project was approved, the BOD scheduled the removal of the trees, which was completed in May 2018.

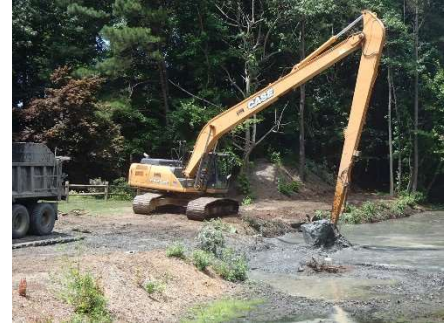
In late June 2018, Lake Services Inc prepared the area for use of heavy equipment and the excavator. On July 5th, they began mechanically dredging the end of Lake 1. Using an excavator with an extended boom, they removed roughly 450 cubic yards of material that accumulated over the years. To provide some perspective, the contractor removed over 6 ft of debris at the deepest sections that had accumulated over the years. This brought the lake depth back down to close to the original design levels shown in the 2000 and 2004 bathymetric studies. These studies are on file on our HOA website. A total of 41 dump truck loads were removed. Each dump truck had to have sealed beds to prevent supersaturated organic “muck” from draining out while transporting the watery material to the disposal site. The pier was removed as part of the project. Once completed, the area used by the heavy equipment was re-graded back to its original condition. Total cost was \$31,700 for the dredging portion of the project.
