Tabb Lakes Dredging Project
Lake #1 North End
Dredged: Sept 2021
Tree Work: July 2022
(21 Oct 2022)

The information below is a synopsis of the process undertaken by the Tabb Lakes Board of Directors (BOD) and Stormwater Committee member in completing the dredging of the north end of Lake 1. All costs are round.

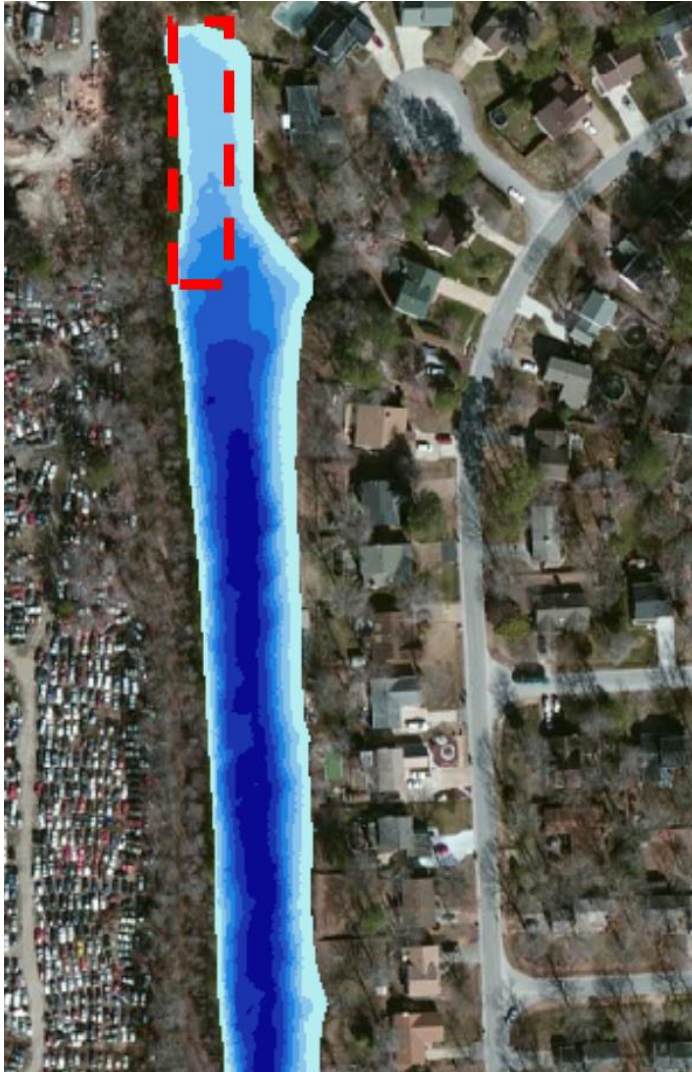
TABB LAKES - Lake 1 area to be dredged.

6. Area is to be dredged to a depth of 6 feet (original design). The slope of dredging next to land is a max of 1:3. For every 3 feet out, the depth increases 1 ft.

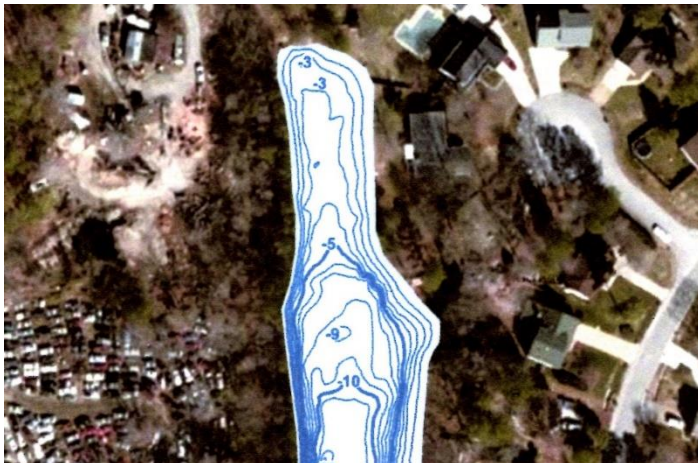
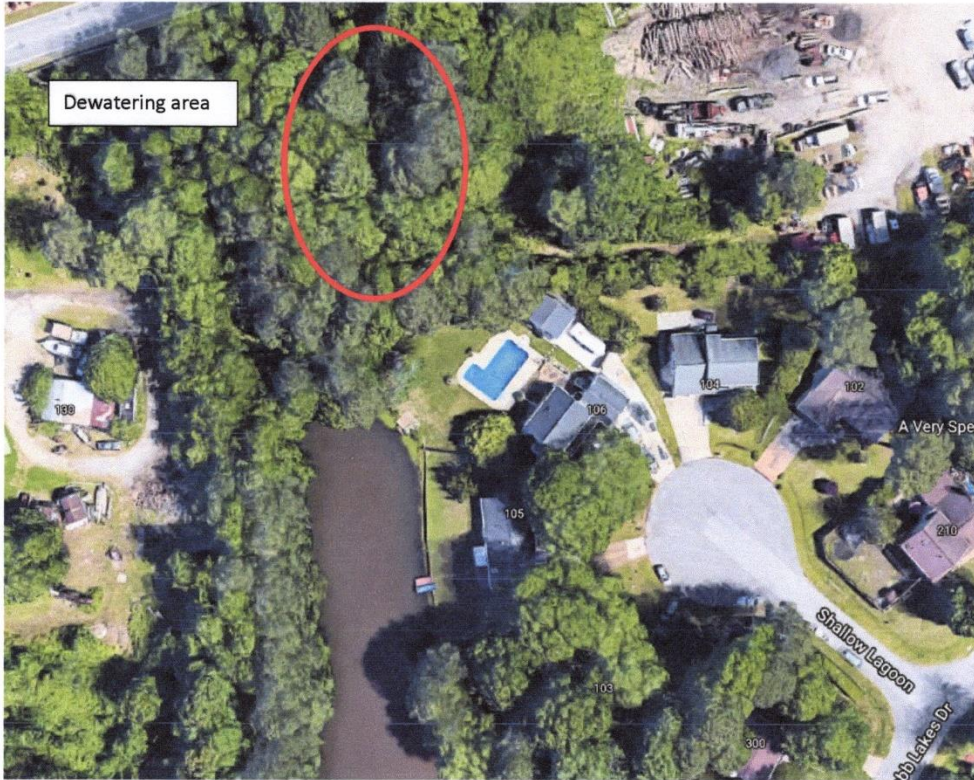
TABB LAKES - Lake 1 sediment depth analysis, 2015 study

After reviewing these initial costs, the board concentrated on dredging the north end of Lake 1 due to the buildup of debris at the area around the outflow of the lakes. Our previous bathymetric studies (2000, 2004, and 2015) and continued visual observations showed that buildup in that area would eventually interfere with the proper drainage of stormwater out of both Lakes 1 and 2.

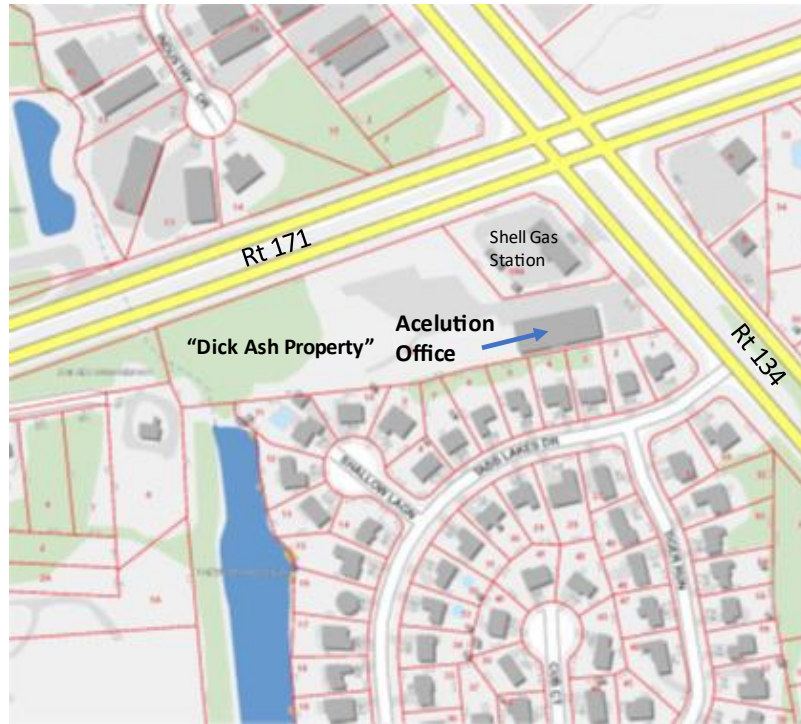
Acelution Inc. Hydraulic Dredging Concepts

- Spoils removed from Rt. 134. (~84 dump truck loads) after dewatering.
- Use of one barge on lake and de-watering site on Dick Ash property.
- Hydraulic barge launched from Bridge Wood Dr.
- Spoils collected in bags. Takes one month to de-water.
- Wire cables spread across lake to control movement of barge (at least two points but could be more). Cables attached to trees on HOA property and steel post set in lake along private property.
- Dredging pump uses ~1,500 gal per min.

4. Water levels in both lakes may drop during the process. Hydraulic dredging sucks up both spoils and water which is then moved by pipe to be deposited in another location (see attachment). This could have an impact on all lake owners. Based on usage factors and lake capacity, we estimate that the lakes will drop 12 to 24 inches from the process. The lakes will refill only after the next several rainstorms.

5. Acelutions will place steel stakes in the lake along the edge of the following properties; 106 Shallow Lagoon, 105 Shallow Lagoon, 103 Shallow Lagoon, and 302 Tabb Lakes Dr. They will not be on private property. Cables will be attached to trees on the west side HOA property. The stakes will be used to attach cables used to control the movement of the dredging barge. (See attached diagram)

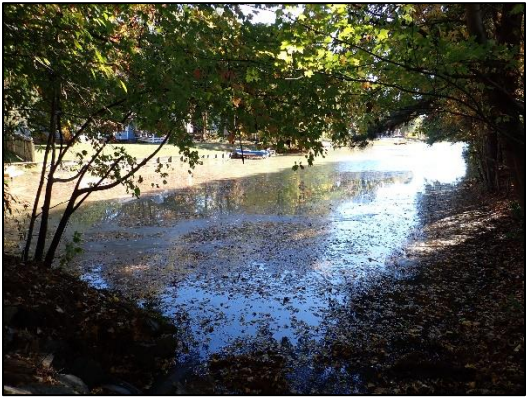
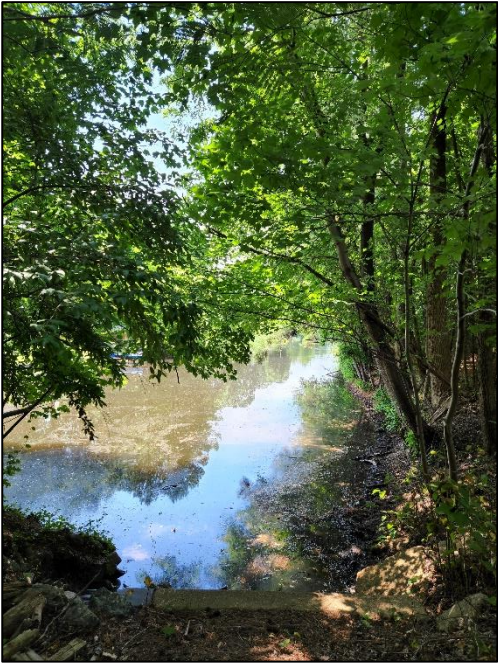
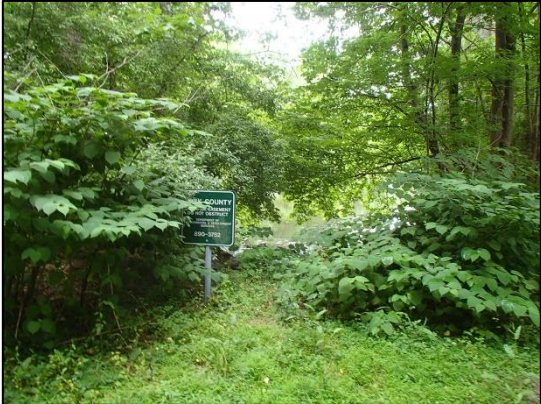
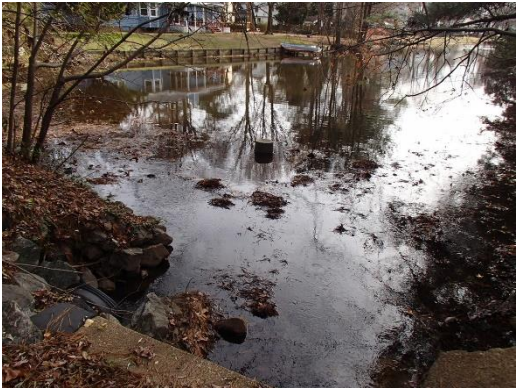
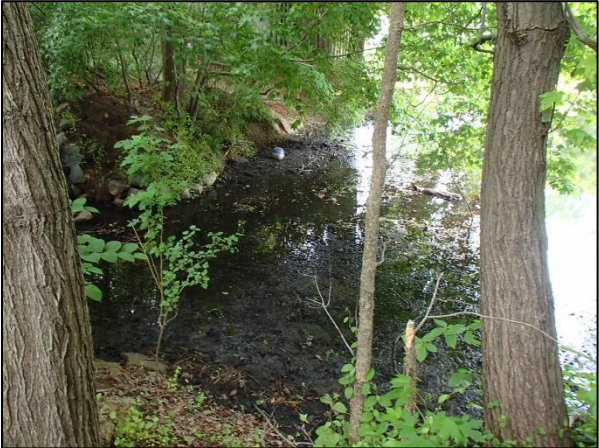
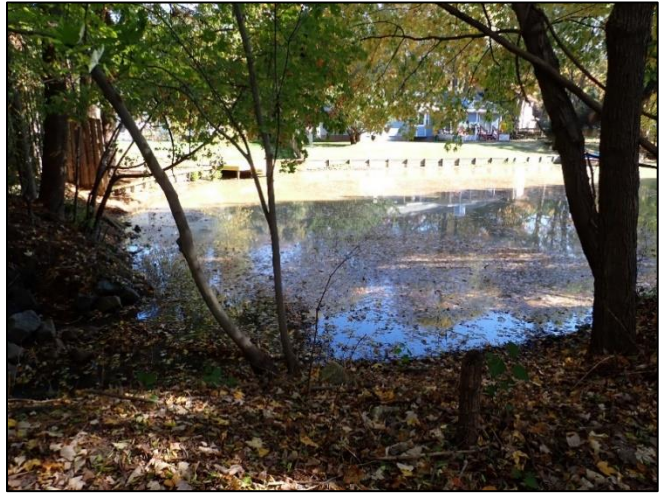
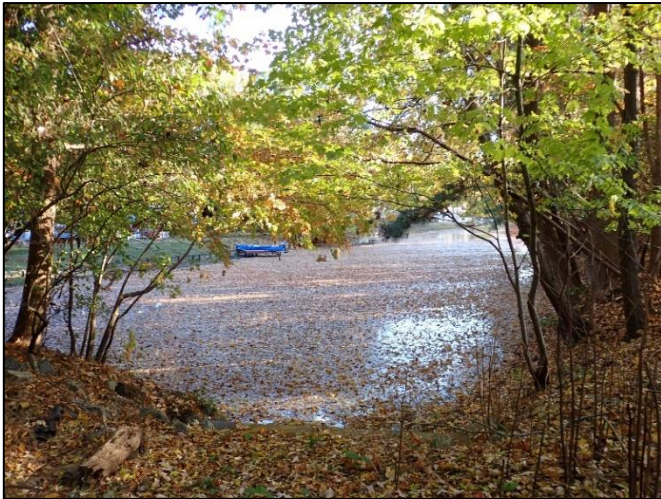
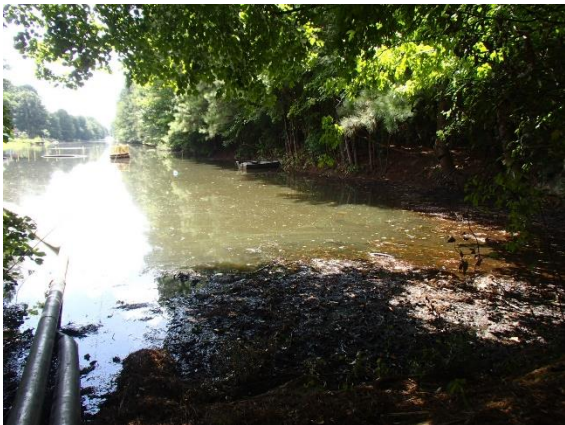
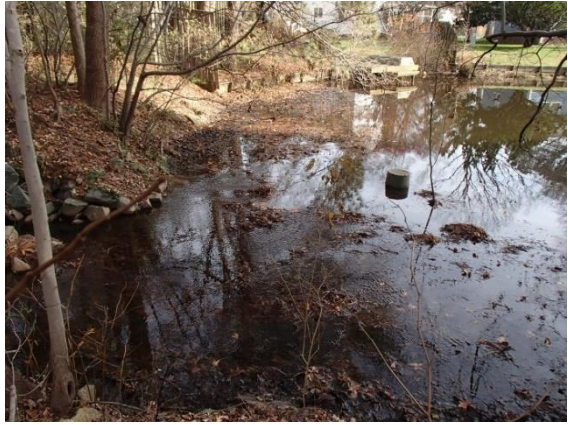
Outflow area before dredging (different seasons)

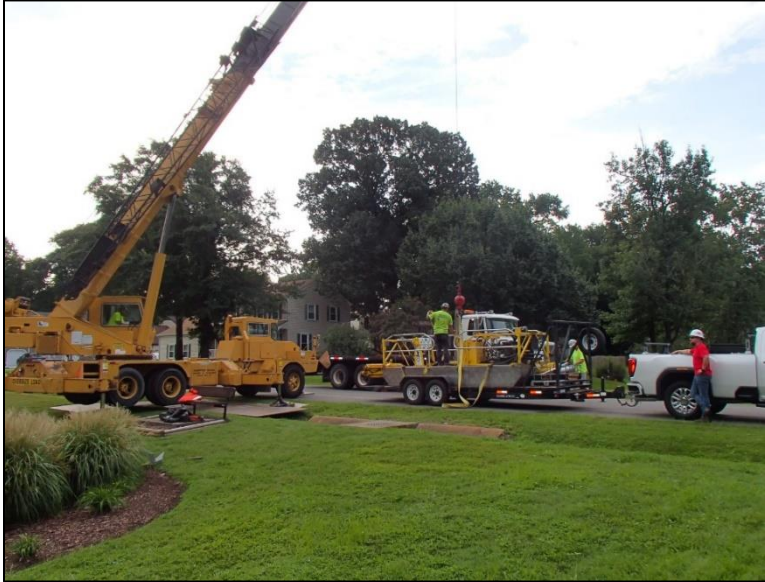
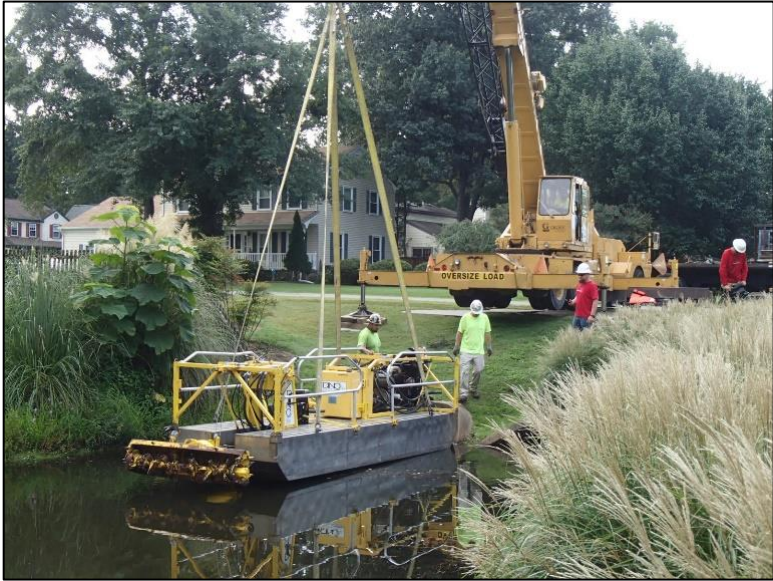
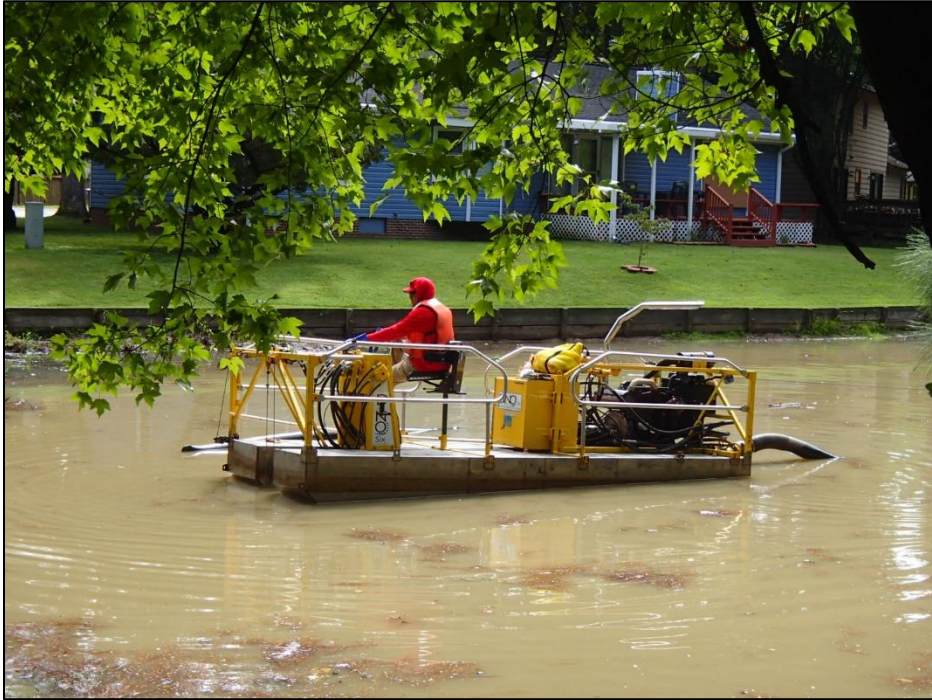
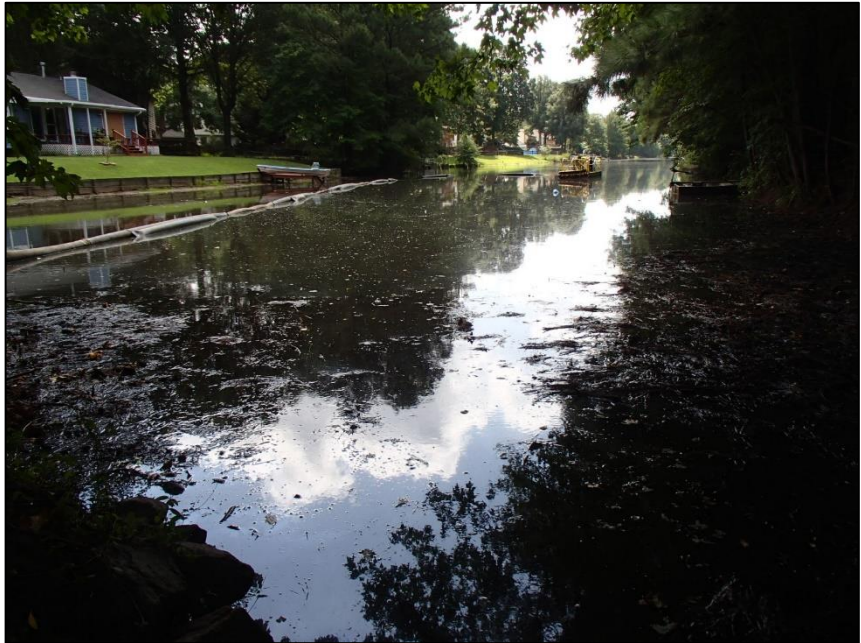
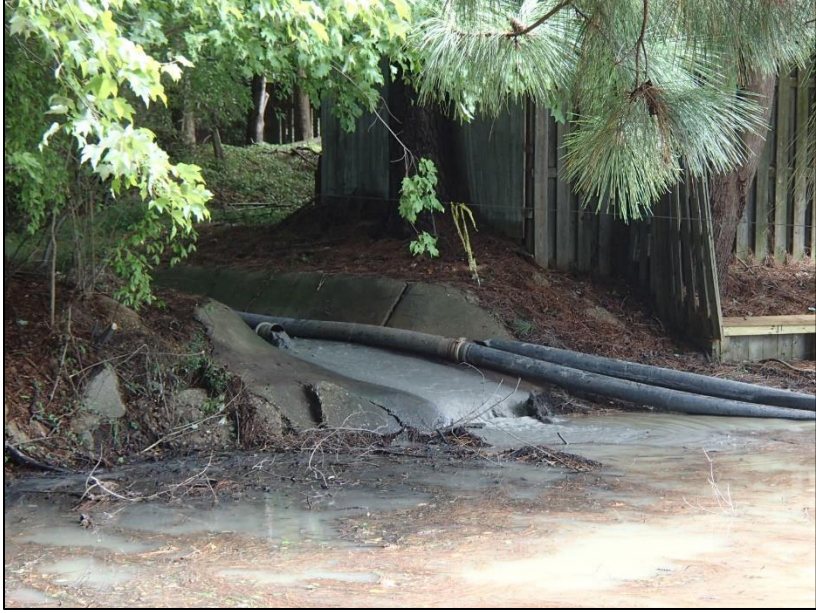
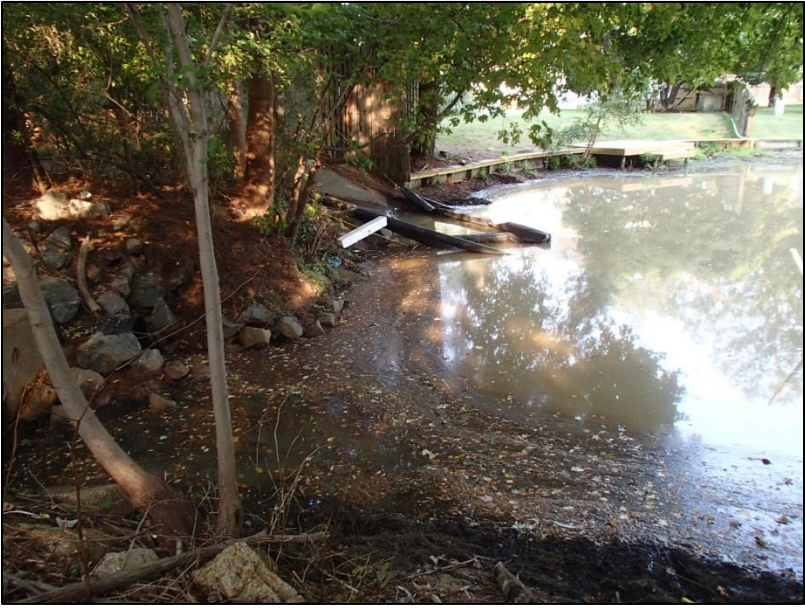
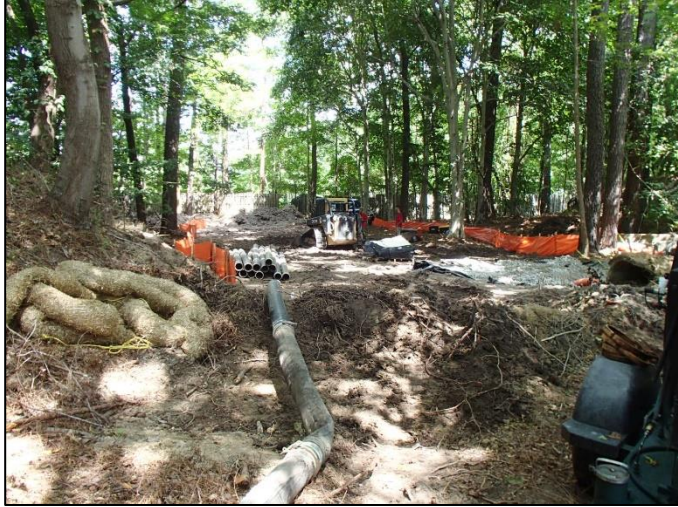
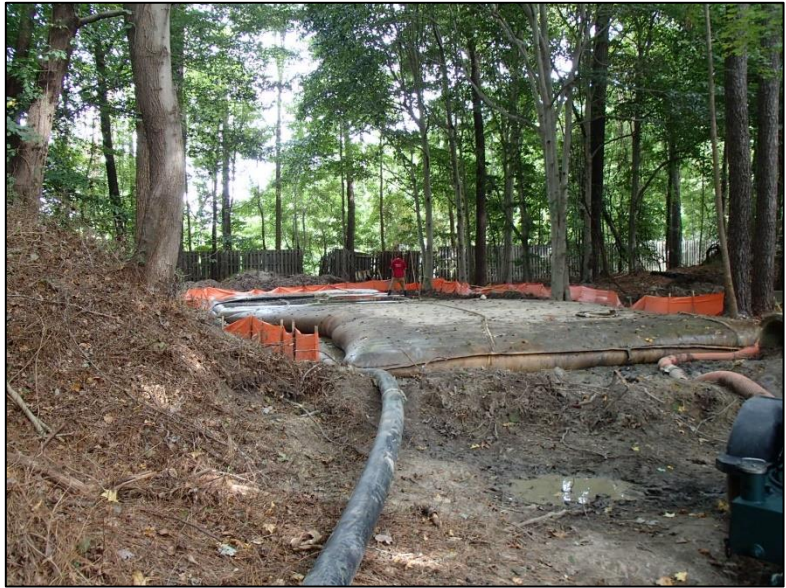
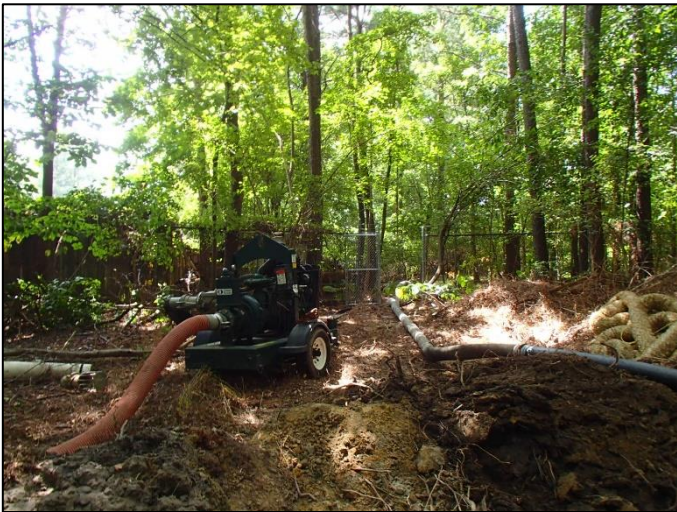
Dredging Project Photos (Aug-Sept 2021)

On 23 Aug 2021, Acelutions Inc. began operations. They temporarily closed off Bridge Wood Dr. and offloaded the dredging barge into Lake 1's south end. Once the barge was in the lake and maneuvered to the north end of Lake 1, they began the process of prepping the area with cables to maneuver the barge during the hydraulic dredging process. Concurrently, they prepared the dewatering area by

digging areas to place the two large dewatering bags, installed the hydraulic pump and required hoses, and installed an inground rock filtering system. This helped separate particles in the water as it was circulated through the dewatering bags and pumped out into the stream. In addition, a hydraulic hose was laid out in the lake and connected to barge.

On 31 August 2021, Acelutions began the actual dredging process. Since there had been concerns that the process could draw down the water on our two lakes, Acelutions decided to direct the outflow water that went through the dewatering bags back into Lake 1 at the emergency spillway area. Screens were placed in front of the outflow pipe to further reduce particles going back into the lake. This helped minimize the impact of lake height changes for both lakes.

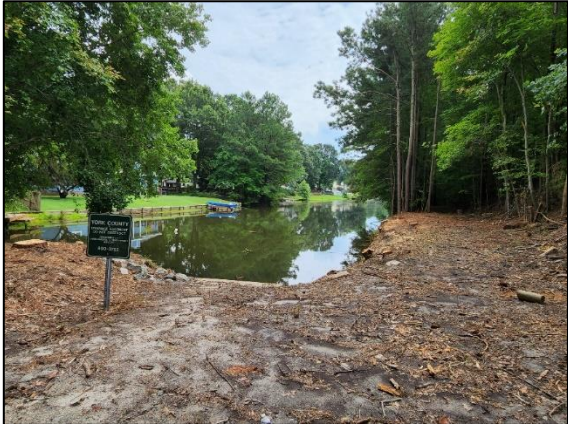
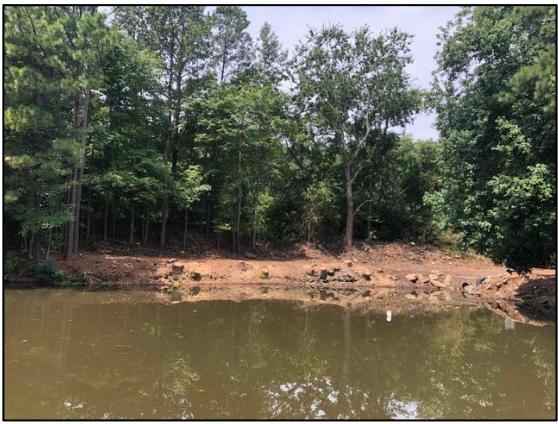
Completed Project (as of July 2022)

In an attempt to minimize the leaves, needles, and debris from surrounding trees dropping into the lake outflow area, the HOA Board had already considered removing the trees and shrubs around that area. This is on HOA common property. That same process was completed when the south end of Lake 1 was dredged back in July 2018. It was originally thought that access from Rt 17 to our lakes with mechanical dredging equipment would require us to remove the trees as part of the preparation for the project. Due to the lack of access, and subsequent change to the method used to do the dredging, this part of the project was considered after the dredging was completed. Acelutions was contacted in Feb, 2022 to see if they had any options of accessing the area. By April, Dan Hobby provided a cost estimate to the HOA Board. He was able to obtain permission from the owner of the property adjacent to the HOA property to bring in heavy equipment from Rt. 17 (at a cost) in order to cut and remove the trees and shrubs. The Board approved the plan and the contract was signed on 21 June 2022. The trees were removed the week of 18 July 2022.

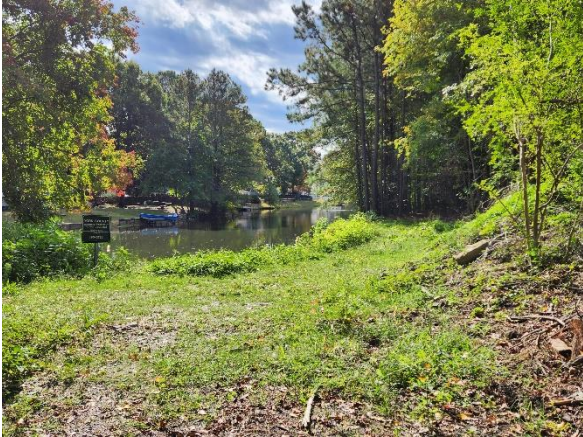
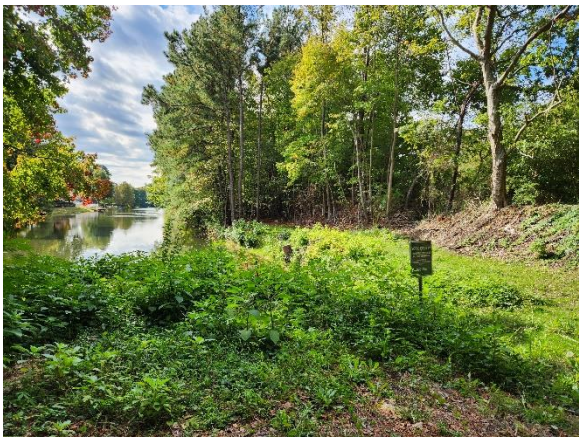
Completed Project (as of October 2022)
