## Tabb Lakes - Retention Lakes Maintenance Program – Diffuser Replacement

## Tabb Lakes - Retention Lakes Maintenance Program Diffuser Replacement Update

## Tabb Lakes - Retention Lakes Maintenance Program - Compressors

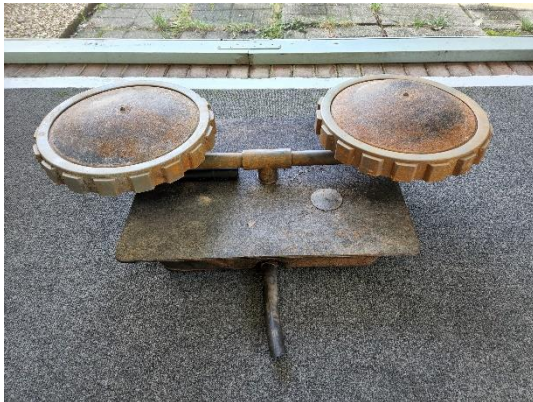
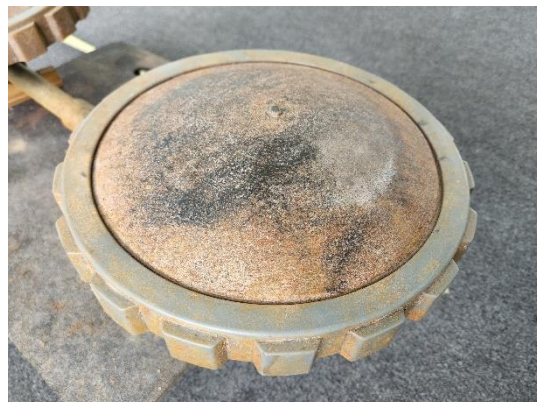
The systems have been operational for about 17 years and runs 24 hrs a day, 365 days a year. Over the years, the compressors have been repaired or replaced as they wear out. Recently, we had to replace the first of the twelve underwater aerators. Since this is the first time anyone has seen what they look like, I have included a picture of the old aerator that was removed. What we found is that, over the years, a hard scale formed over the two diffuser's rubber diaphragms. This eventually restricted the air flow into the water, reducing their effectiveness and possibly putting a strain on the compressor.

The HOA board is now evaluating the condition of the remaining eleven aerators and possibly replacing those that are near the end of their life cycles.

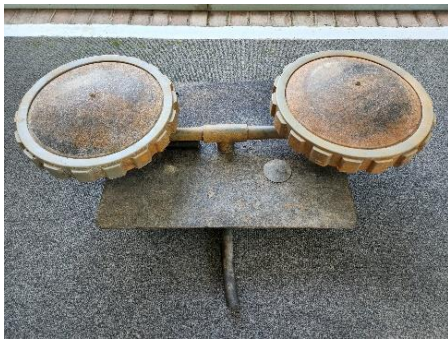
*Old diffuser (installed in 2005  
and removed in 2022)*

The HOA board approved replacing all 12 diffusers (6 in each lake) since the original diffusers were becoming clogged after 17 years of continuous operation. On October 2022, SOLitude Lake Management completed the replacement of the diffusers along with some additional maintenance on the air supply hoses. The cost of replacement was about \$6000. Below are pictures of the old and new diffusers.

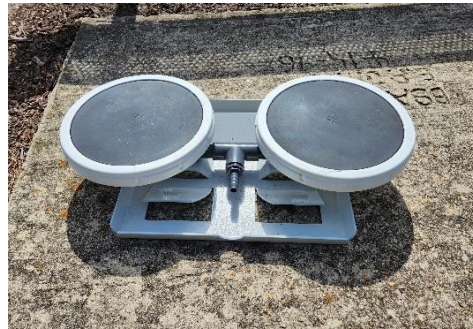
*New diffuser (installed in 2022)*

Since this is the first time we replaced our diffusers, we now have a timeline for future repairs that we can calculate into our HOA planning and budget. We can plan for a life expectancy between 15-20 years; we know these new diffusers are easy to “hook and capture” to pull up to the surface for inspection and possible repairs; and the rubber diaphragm (2 per diffuser) is replaceable, so the costs of future repairs should be reduced.

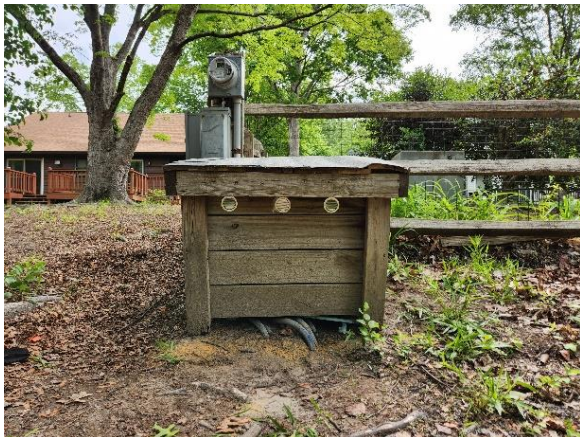
*Photo 1*

The compressors provide air to the diffusers in the lakes and run 24 hrs a day / 365 days a year. Each lake has two compressors that maintain air flow to the six diffusers in each lake. The two compressors are in containers located several feet from the lake bank at about the central point along each lake. They are collocated with the location of the electrical junction box and electric meter that was installed to provide the power connection to the fountain/lights in each lake. Photo 1 is a picture of the Lake 1 compressor area showing the wooden sound box covering the compressor's metal container. Lake 2 has a similar setup. You can see the electrical box connection and the electric meter behind it. That is also the location of the relay switch that typically needs to be reset when the fountain goes out due to an electrical overload.

The wood box was built by a previous board member and installed over the metal container back in 2005 to reduce the sound of the compressors to the homeowners. Without them, the compressors can be heard when nearby even though they are housed in a metal container. Photo 2 shows the wooden top and sides removed so you can see the metal container.

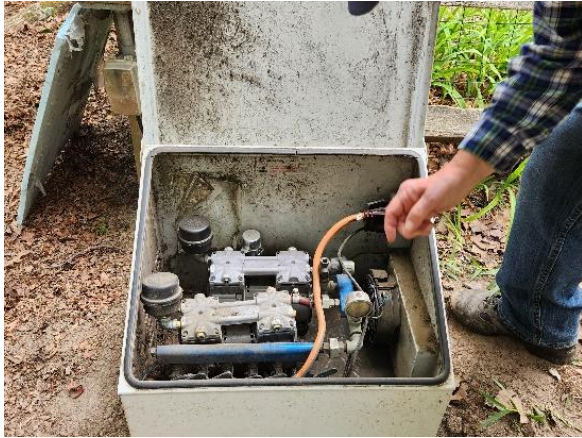
*Photo 3*

Photo 3 shows the open metal container and the two compressors along with the electrical connections and an electrical ventilation fan on the right side to minimize the heat buildup in the container. Each compressor pumps air into three hoses that provides compressed air to three underwater diffusers. There are six diffusers per lake hence 2 compressors per lake. Photo 4 shows the assembled containers and electrical connections from a different angle.
