Subject: BMP inspections, Tabb Lakes, York County, VA

# SWMF Inspection Form

**Site** Tabb Lakes- Lake 2 **Inspector Name** Leah Aguilar  
**Site ID** T02a-0026-4932 **Inspection Date** 10/29/2013  
**SWMF** T02a-0026-4932 **Follow Up Action Required** Yes  
**SWMF Type** Retention Basin **Notes:**

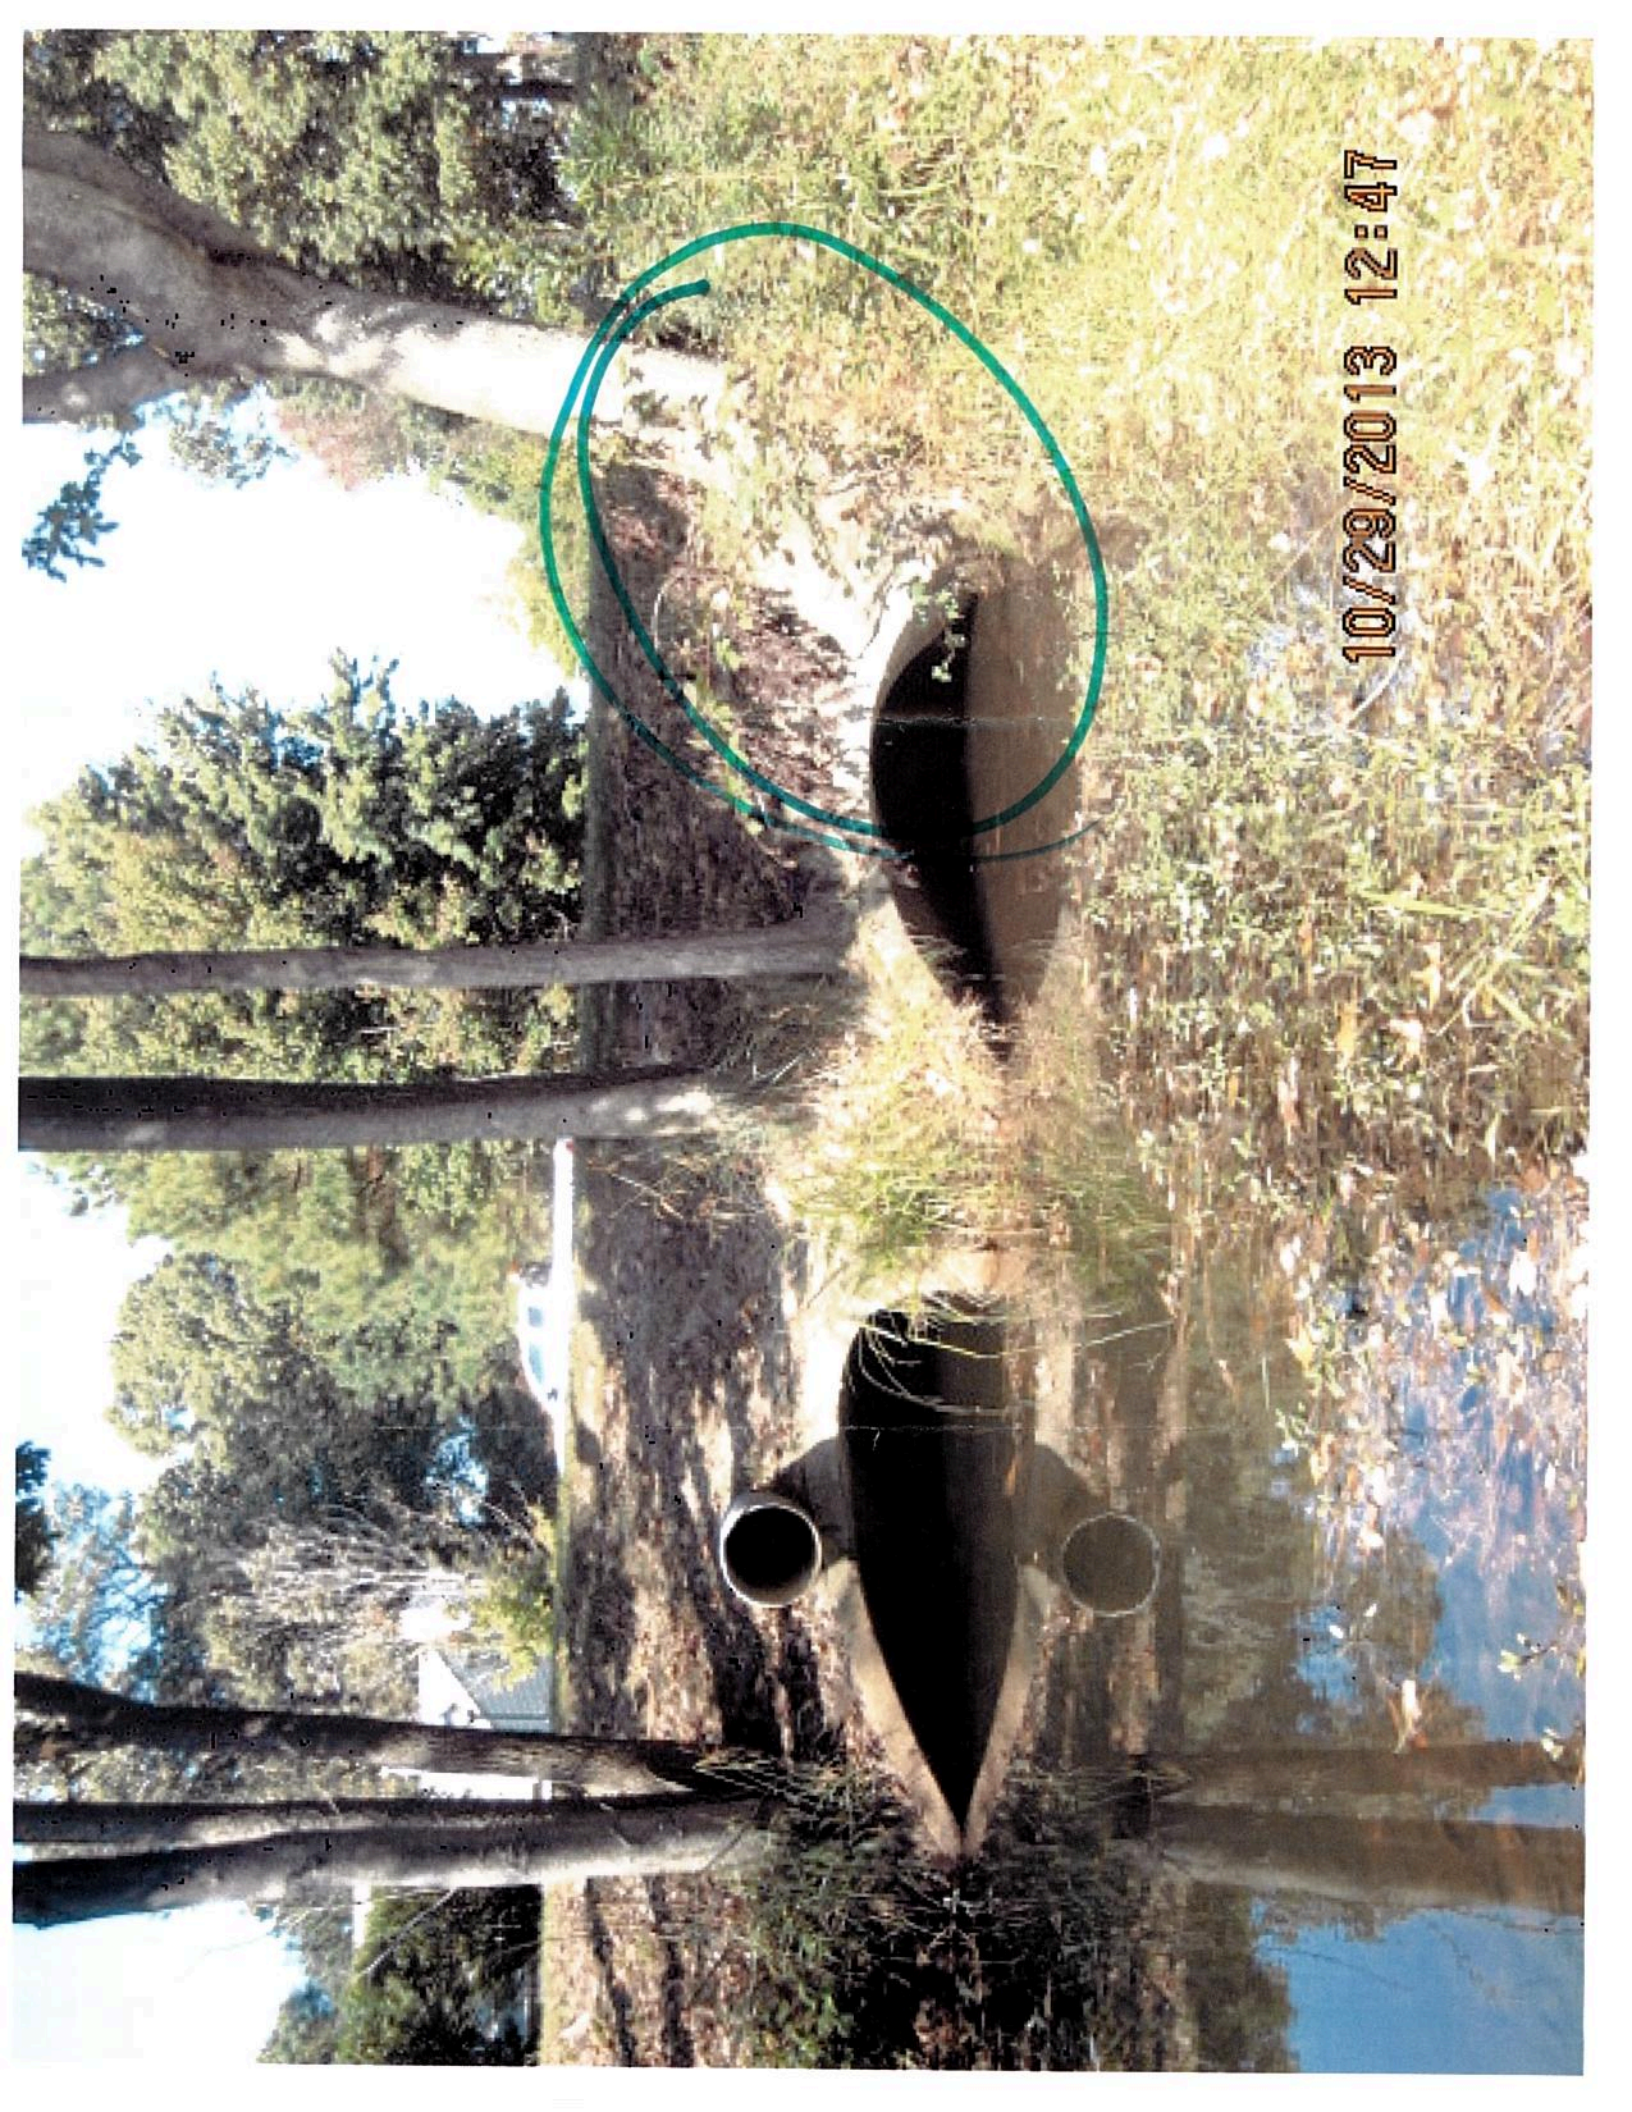
10/29/2013 12:47

Criteria	Sat/UnSat/NA	Comments
1. <b>Forebay</b> (> 50% filled with sediment = UNSAT and check ATTN required)	NA	
2. <b>Inlet(s)</b> (note signs of erosion, low spots)	Sat	
3. <b>Outlet</b> (note signs of erosion, damage, obstructions)	Unsat <i>Picture enclosed</i>	There are trees growing over/near to the outlet pipes that should be removed. Fluted end section on right pipe has started to separate due to roots.
4. <b>Principal Spillway</b> (note signs of erosion, obstructions, seeping)	Sat
